## Oil Analysis Report [OLXX03]

### Demo Company - All Modules

Tag Number: PT4545

<b>Asset Tag:</b>	PT4545	<b>Serial No.:</b>	123456
<b>Site:</b>	Site 1	<b>Area:</b>	Substation 1
<b>Power Rating:</b>	17.50 MVA	<b>Voltage:</b>	132kV/11kV
<b>Oil Volume:</b>	1000L	<b>Insulation Fluid:</b>	Mineral Oil
<b>Manufacturer:</b>	Wilson	<b>Asset Class:</b>	Power Transformer
<b>Sampling Point:</b>	Bottom Valve	<b>Cooling:</b>	ODWF
		<b>YOM:</b>	1977

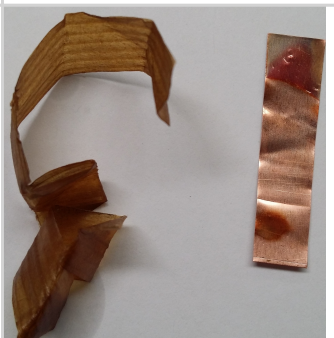
Details	Class	Paper Description	Copper Description	Photo
Sample ID: TX0003 Date: 1/11/2020	Non Corrosive	No deposits visible	1a - Slight Tarnish Light Orange, almost the same as freshly polished strip

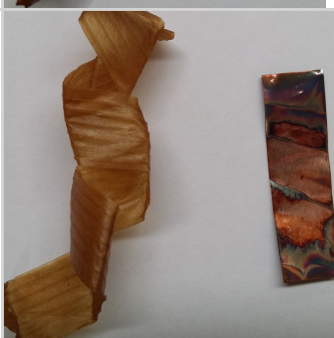
Sample ID: TX0002 Date: 24/02/2015	Non Corrosive	No deposits visible	4a - Corrosion Transparent Black, Dark Gray or Brown with Peacock Green barely showing

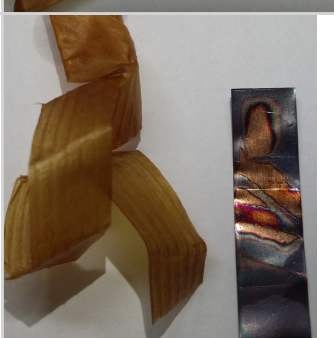
Sample ID: TX0001 Date: 23/01/2011	Potentially Corrosive	No deposits visible	4b - Corrosion Graphite or lusterless Black

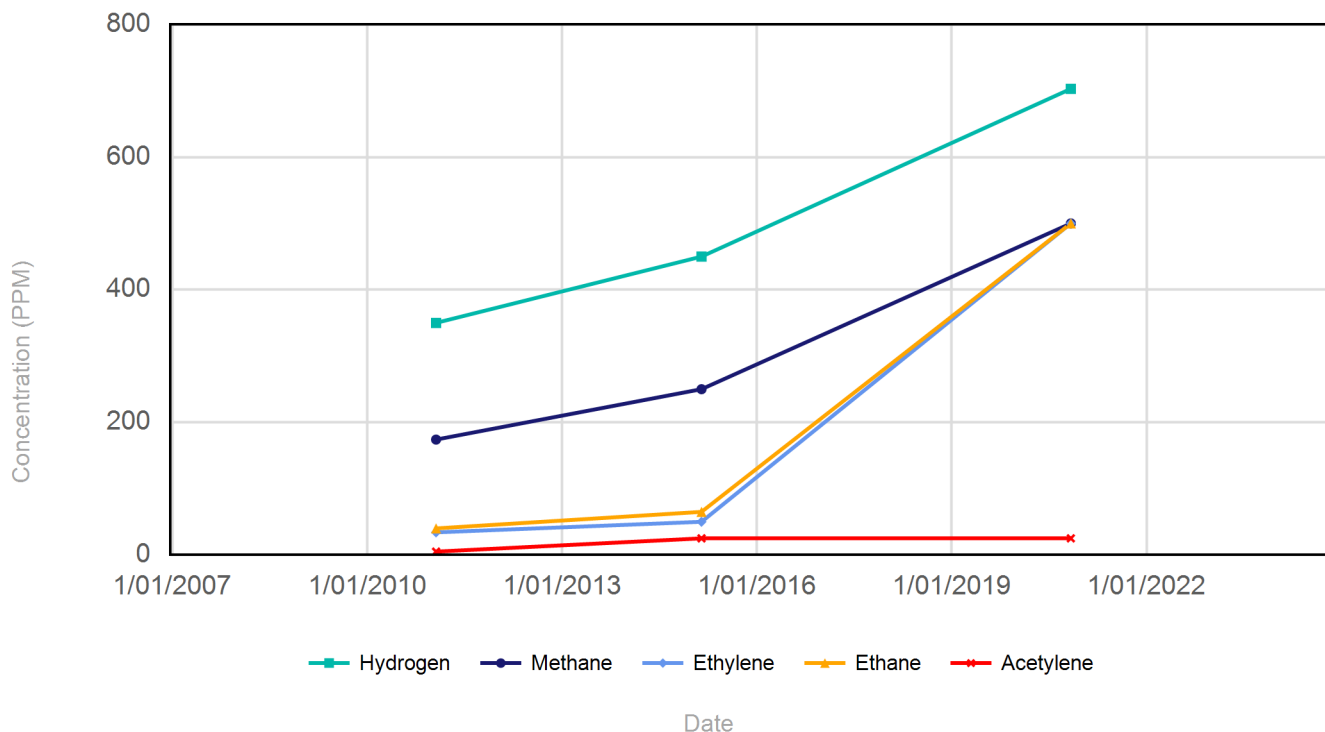
### Dissolved Gas Analysis

This sample is classified as DGA Status 3. Hydrogen, Methane, Ethane, Ethylene and Acetylene gas levels are exceedingly elevated.  
Exercise extreme caution. Plan outage.

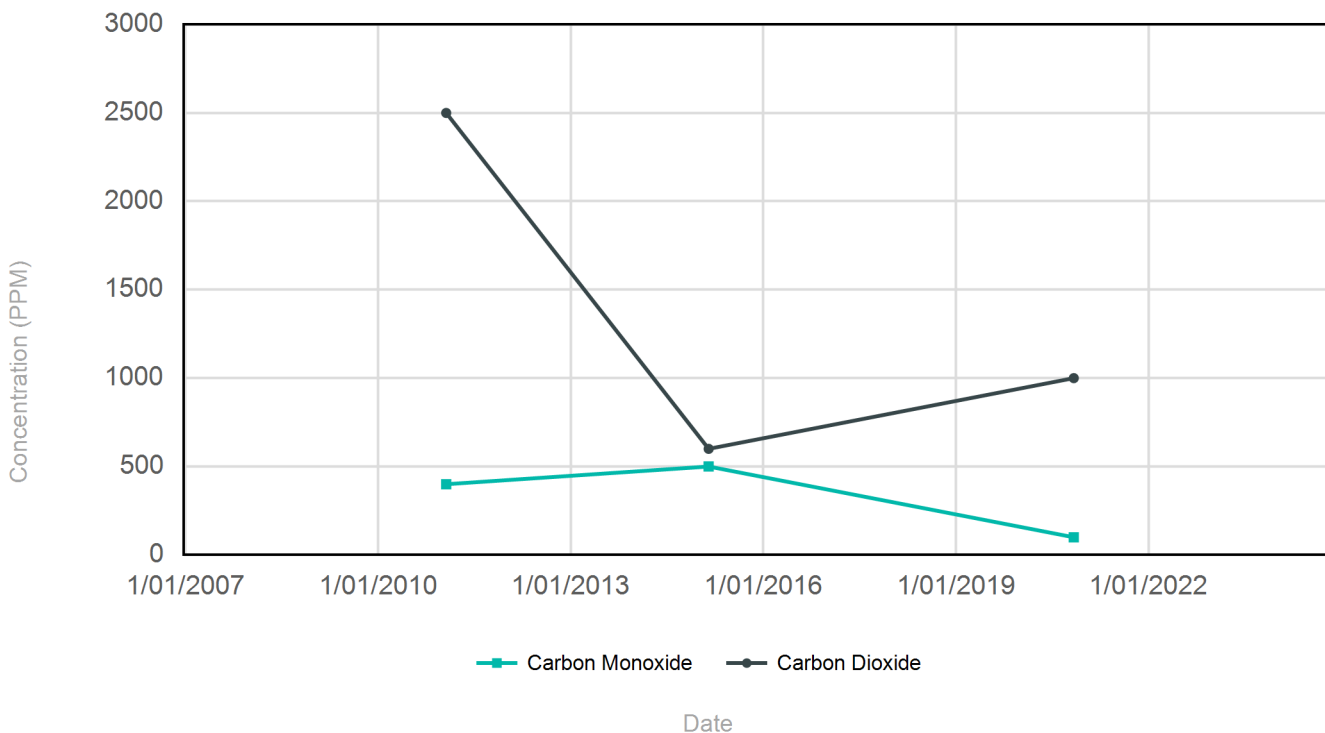
### Carbon Oxides

CO2/CO ratio: Normal operation.

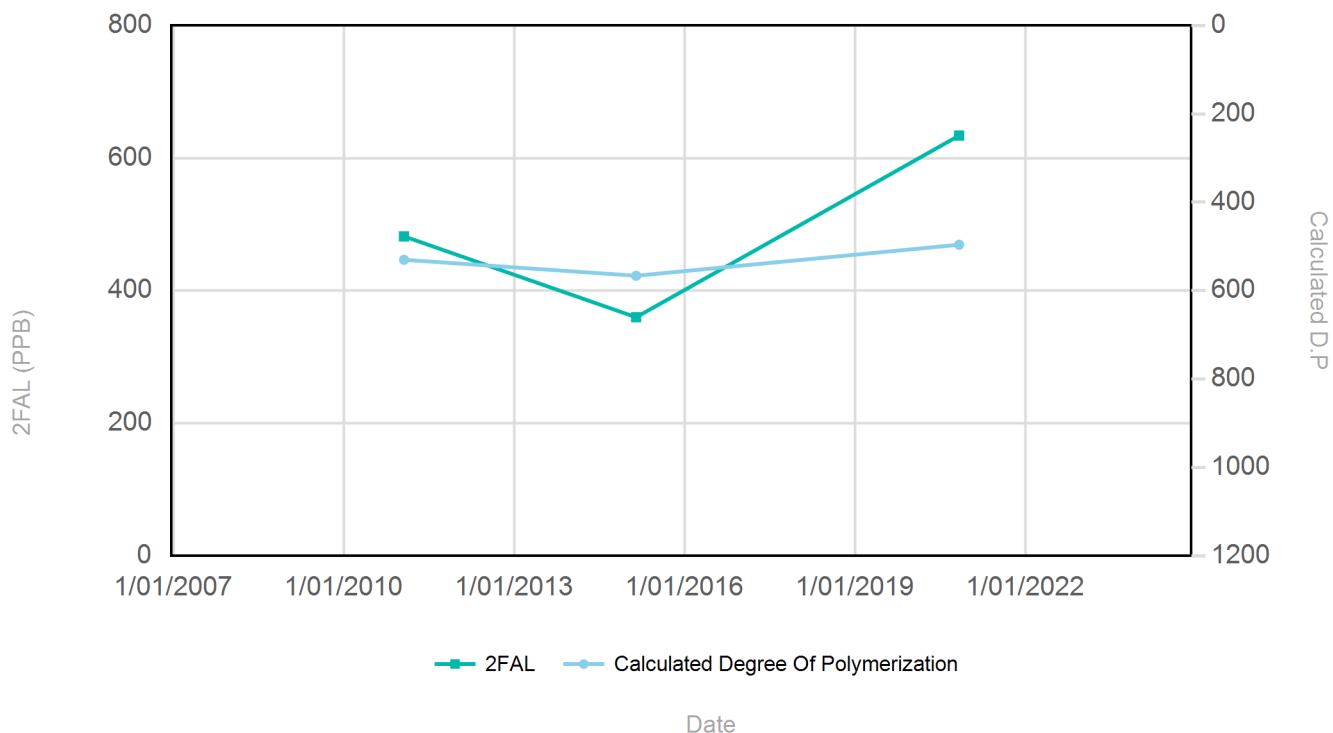
## Furanic Compounds

Based on the 2FAL levels found in the sample, the estimated life remaining in the paper is 66%
