Oil Analysis Report [OLXX03]

Demo Company - All Modules

Tag Number: PT4545

Wednesday, November 4, 2020

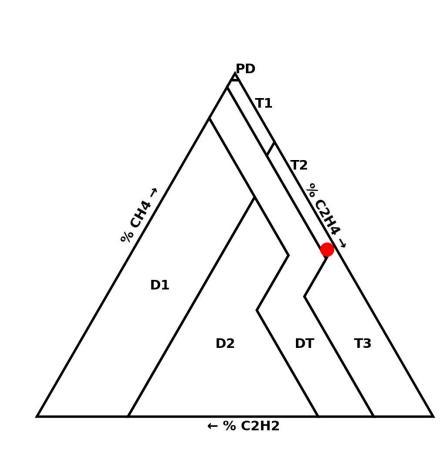
Triangle 1

Classical Triangle for Mineral Oils

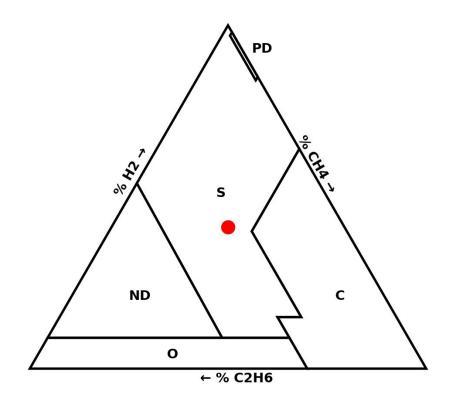
Triangle 4

Low Temperature Faults in Mineral Oils. This triangle is used for a more precise diagnosis of faults identified as low temperature (PD, T1 or T2) by Triangle 1. Do not use for faults D1, D2 or T3.

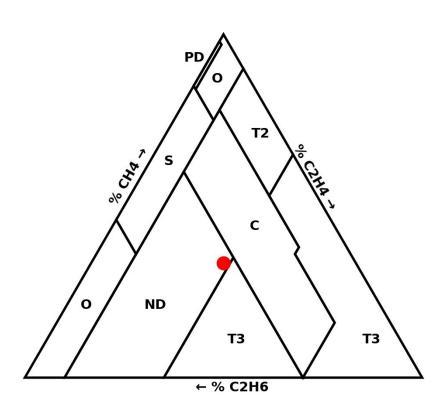
Triangle 5

Low Temperature Faults in Mineral Oils. This triangle is used for a more precise diagnosis of faults identified as low temperature (PD, T1 or T2) by Triangle 1. Do not use for faults D1 or D2.
