Oil Analysis Summary Report

Job Number: OLXX03

Customer: Demo Company - All Modules

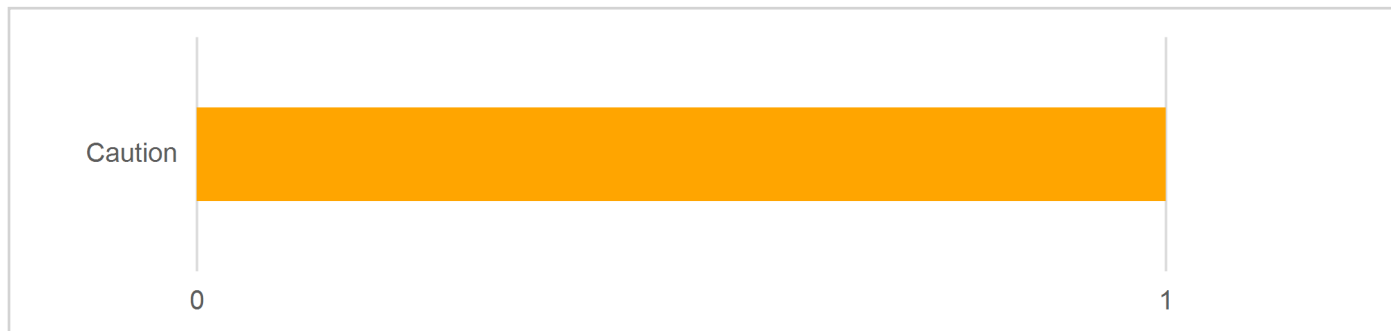
Tx Data	Condition	Comments / Recommendation	Next Sample Date
SERIAL NO: 123456 TAG NO: PT4545 LAST SAMPLE: 29/02/2016	Caution	<p>IEEE Dissolved Gas Interpretation (C57-104): This sample falls under IEEE TDCG Condition 3. Hydrogen, Methane, Acetylene, Ethylene and Ethane levels are exceedingly elevated. In addition, Doernenburg Ratio and Furans may show a point of concern. Exercise extreme caution. Plan outage.</p> <p>The 2FAL levels found in the sample (624 PPB) are high for the age of this transformer. The IEEE recommended sampling period is: Monthly.</p> <p>Diagnosis based on Gas Ratios : CO2/CO ratio: Normal operation Doernenburg: .</p> <p>Interpretation of Oil Quality Properties as per IEEE C57-106 - 2006 Colour : Complies Breakdown Voltage : Complies Water Content : Complies Acidity : Complies Interfacial Tension : Complies Power Factor @ 25°C : Complies Power Factor @ 100°C : Complies PCB : Complies Specific Gravity : Complies</p>
